FORENSIC CAUSATION REPORT

Proprietary Damage Assessment & Causation Analysis

Prop: [REDACTED] JSA

Date of Loss: July 8, 2021

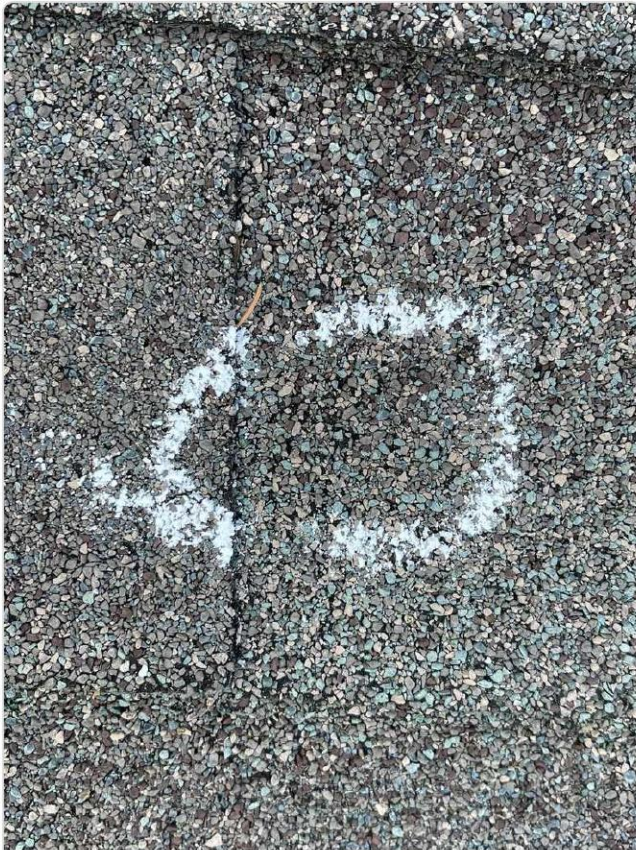
Chalk-circled hail strike on shingle shows granule loss and mat fracture at impact point.

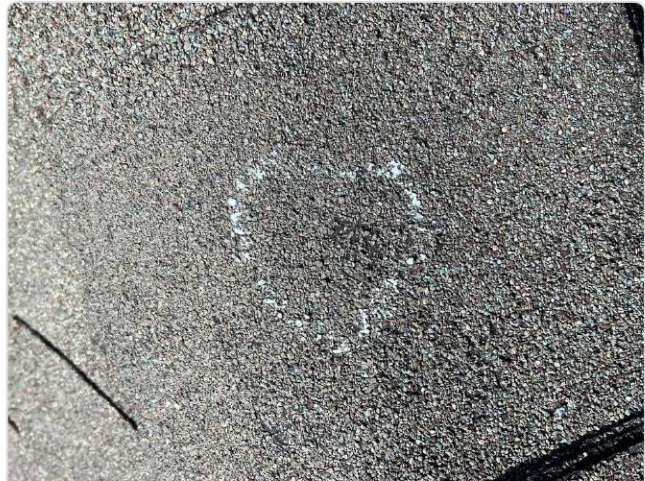
Chalk-circled hail impact on shingle surface with granule displacement — mat fracture confirmed.

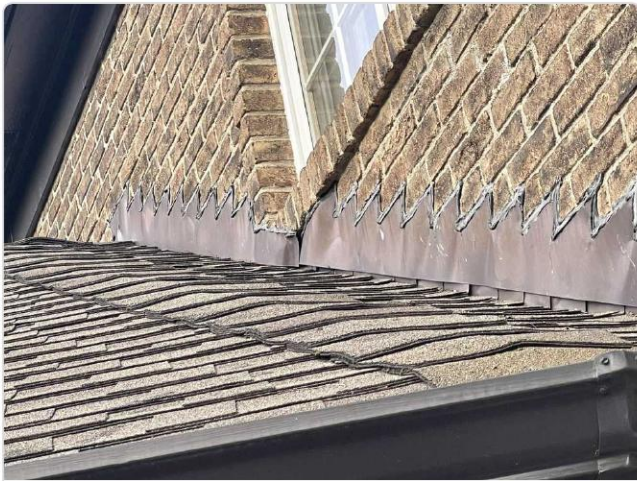
Step flashing at brick wall shows severe distortion and lifting; shingle courses along transition exhibit hail damage.

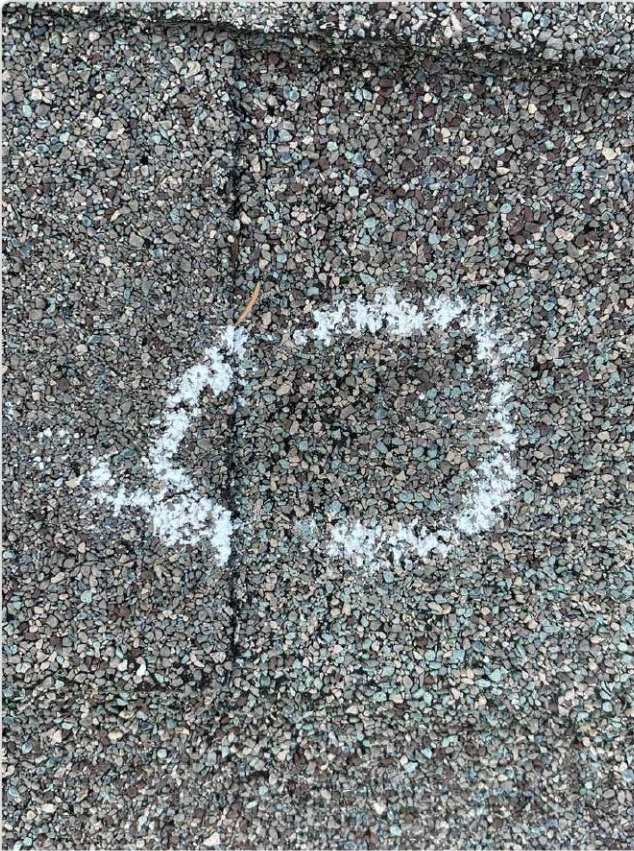
Chalk-circled hail strike on shingle shows granule loss and mat fracture at impact point.

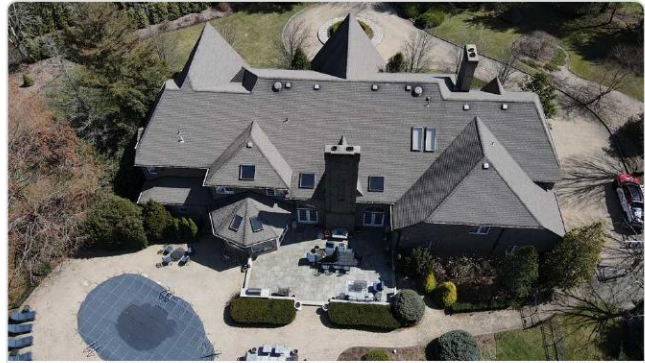
Aerial overview reveals complex roof with 7 skylights, multiple valleys, and copper flashings requiring full replacement.

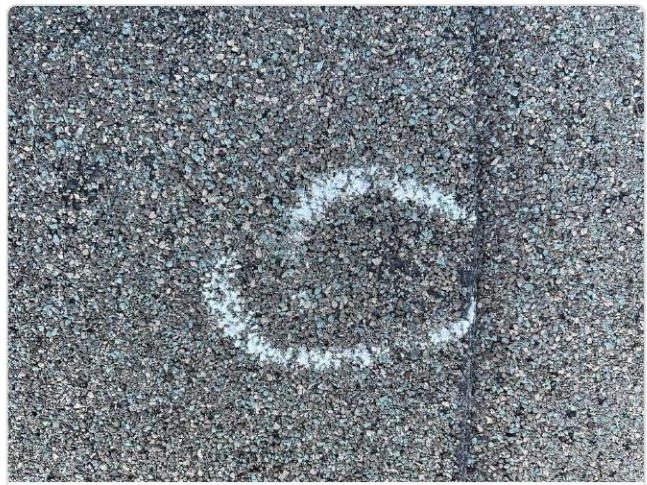
Chalk-circled hail impact on flat slope confirms repeatable dent pattern with granule displacement.

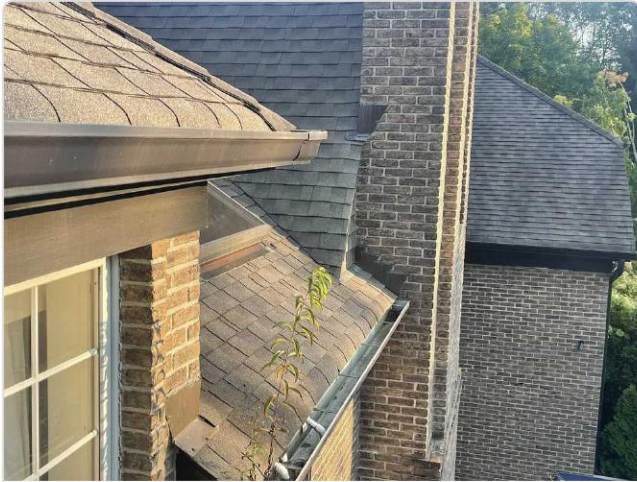
Wall-to-roof transition shows aged step flashing with plant growth in gutter — debris retention compounds storm vulnerability.

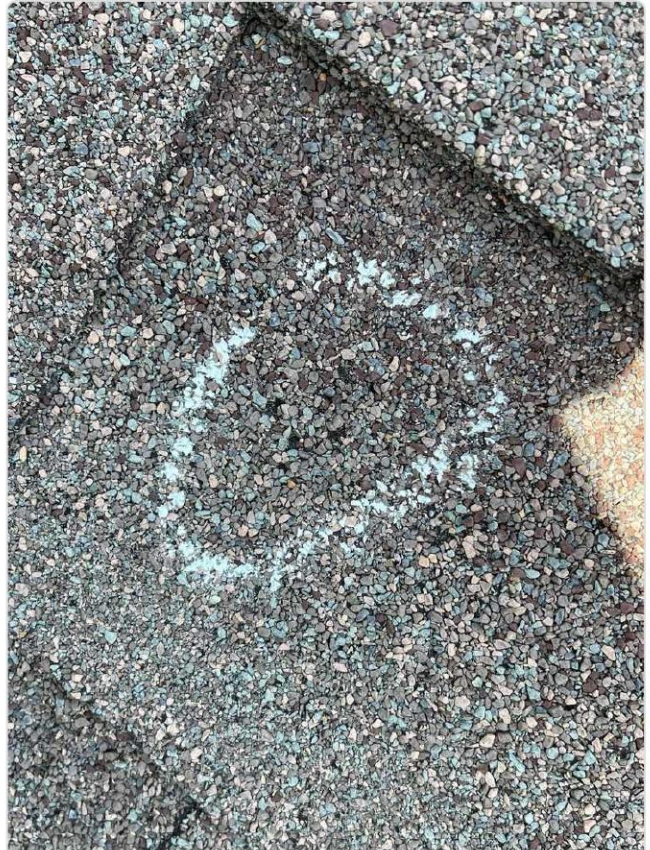
Chalk-circled hail strike on shingle shows granule loss exposing dark asphalt mat — confirmed impact fracture.

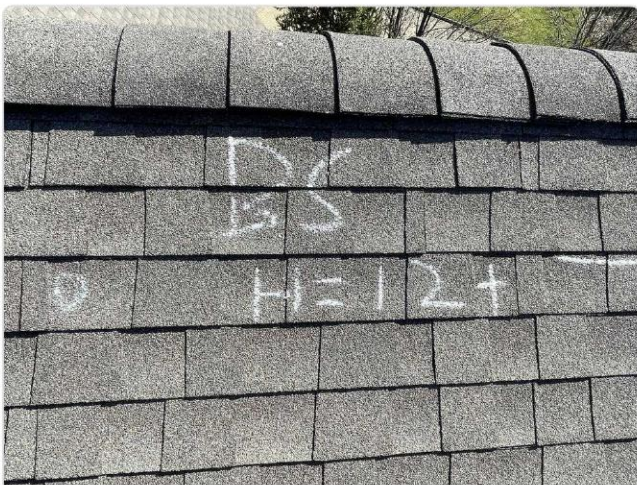
Test square markings on slope read H=12+ with chalk notation — documents hail hit density per test area.

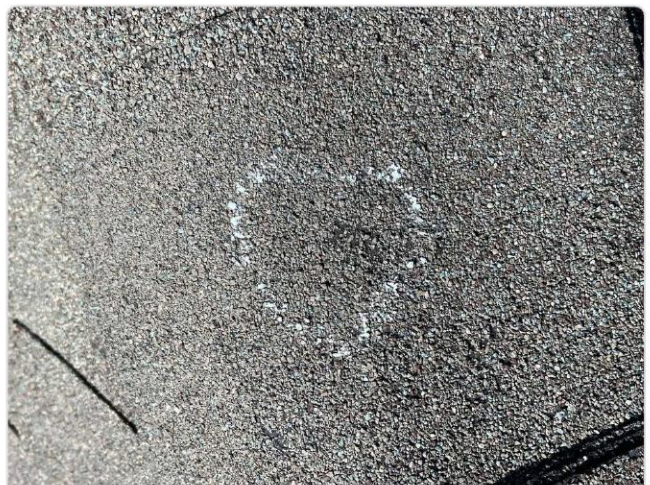
Chalk-circled hail impact on shingle surface with granule displacement — mat fracture confirmed.

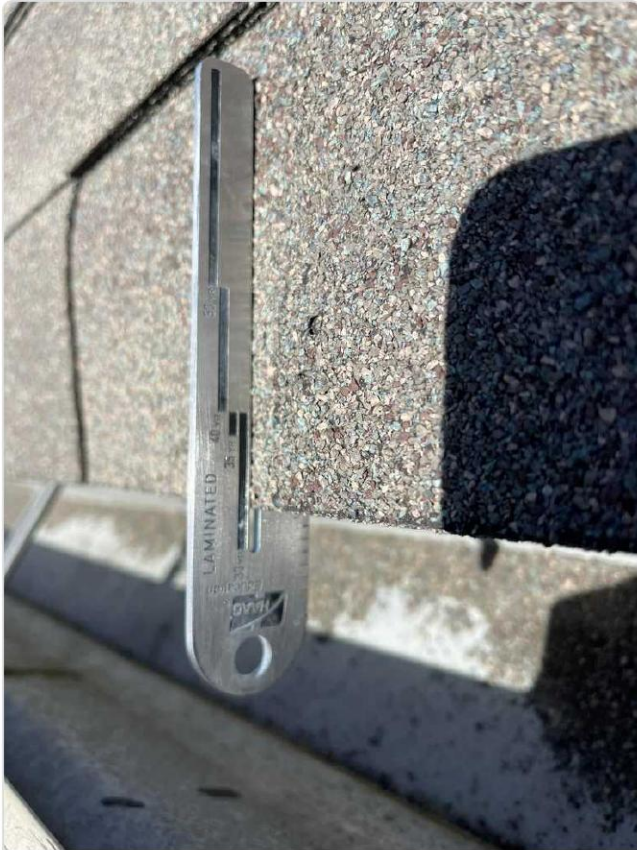
HAAG hail gauge on laminated shingle measuring impact diameter — professional damage documentation.

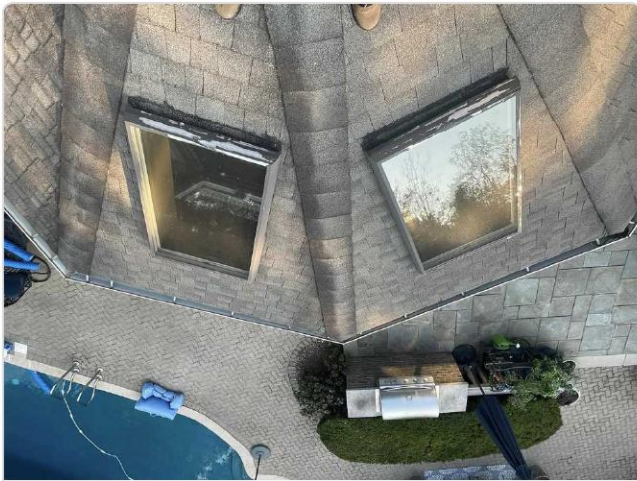
Aerial overview shows complex roof with dual skylights, multiple valleys, and hail-vulnerable copper flashings over pool area.

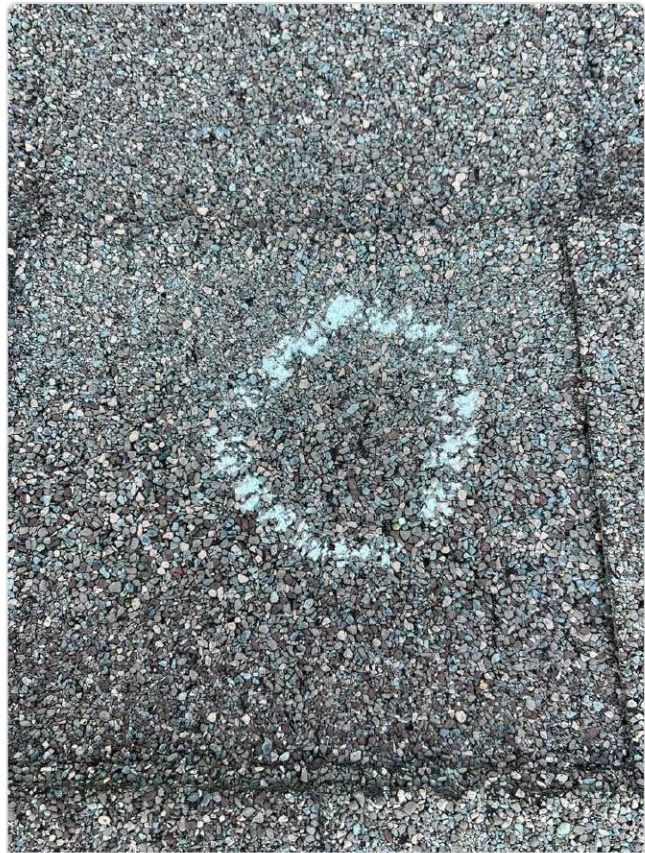
Chalk-circled hail strike on shingle shows granule displacement exposing dark asphalt mat — confirmed hail impact.

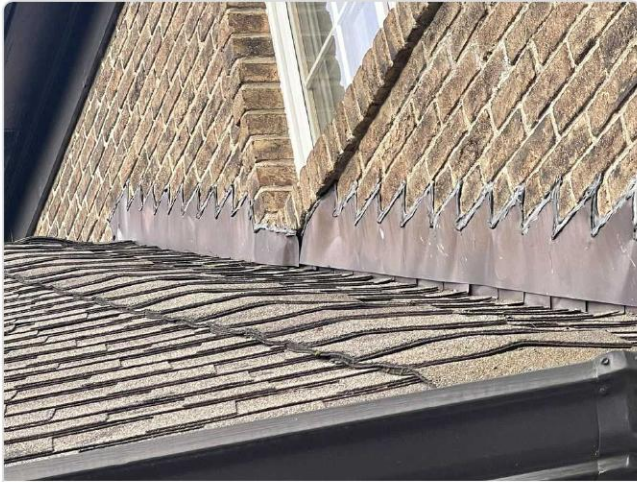
Step flashing at brick wall shows severe distortion and lifting; shingle courses along transition exhibit hail damage.

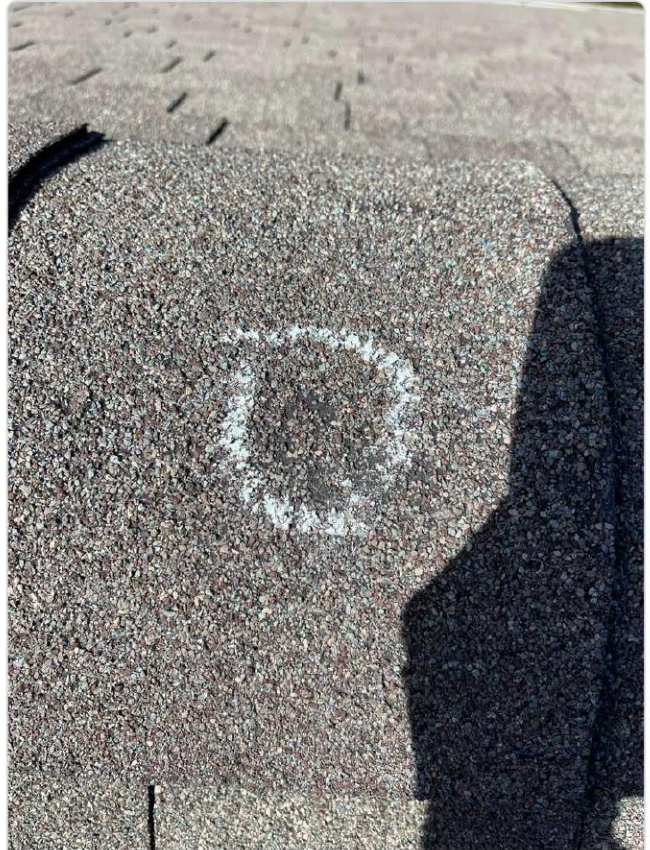
Chalk-circled hail hit on flat slope near wall-to-roof transition shows granule loss exposing mat substrate.

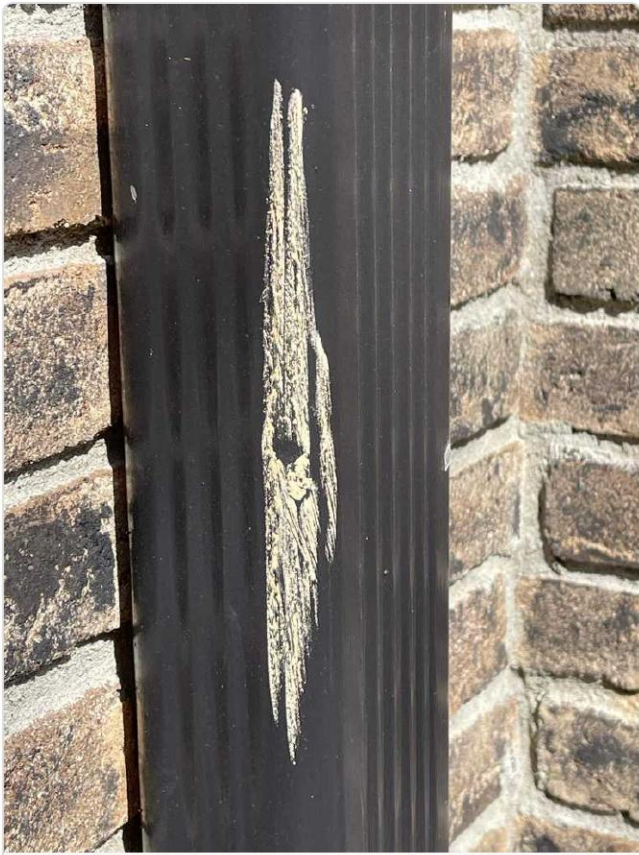
Chalk test on aluminum downspout reveals circular gaps in chalk line confirming multiple hail dent impacts.

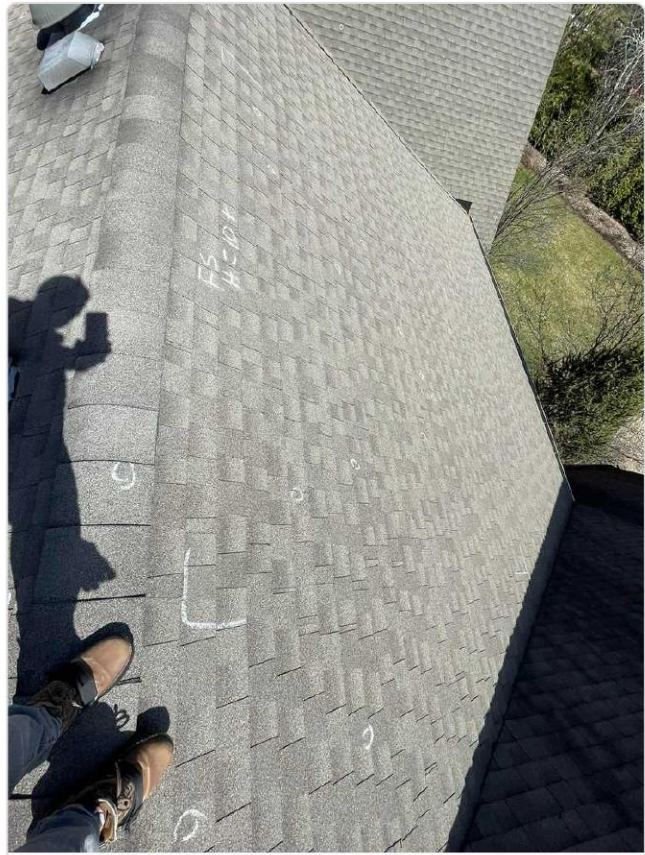
Chalk test square on slope with H=10+ hail hits circled; multiple marked impacts confirm storm damage pattern.

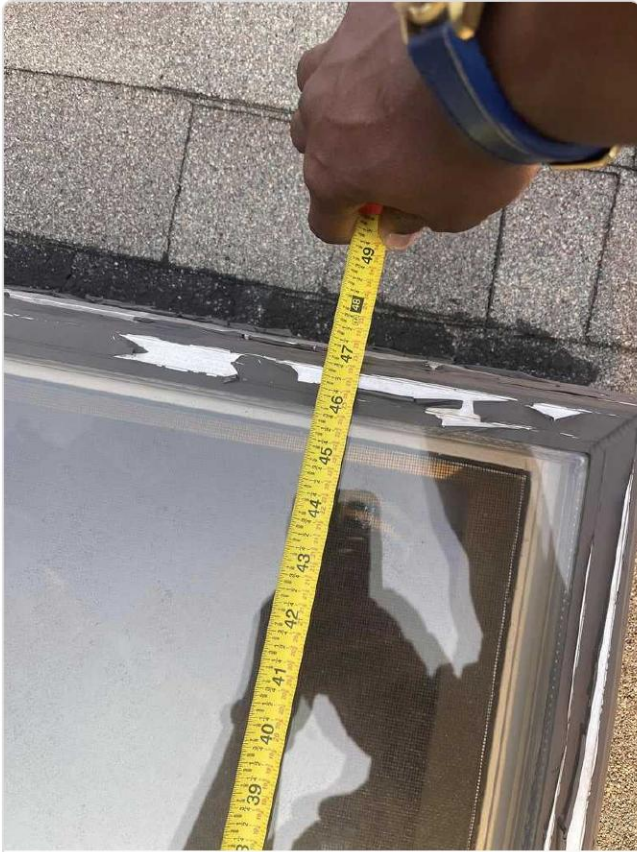
Skylight frame measured at ~49 inches; flashing sealant deterioration and hail-exposed edges visible at top rail.

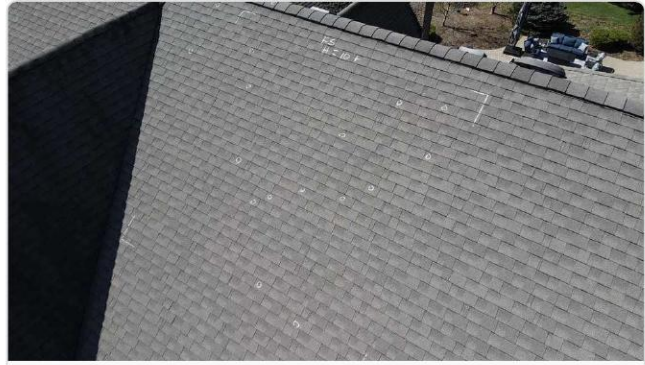
Front slope test square reads FS H=10; 20+ chalk-circled hail strikes across field confirm replacement threshold.

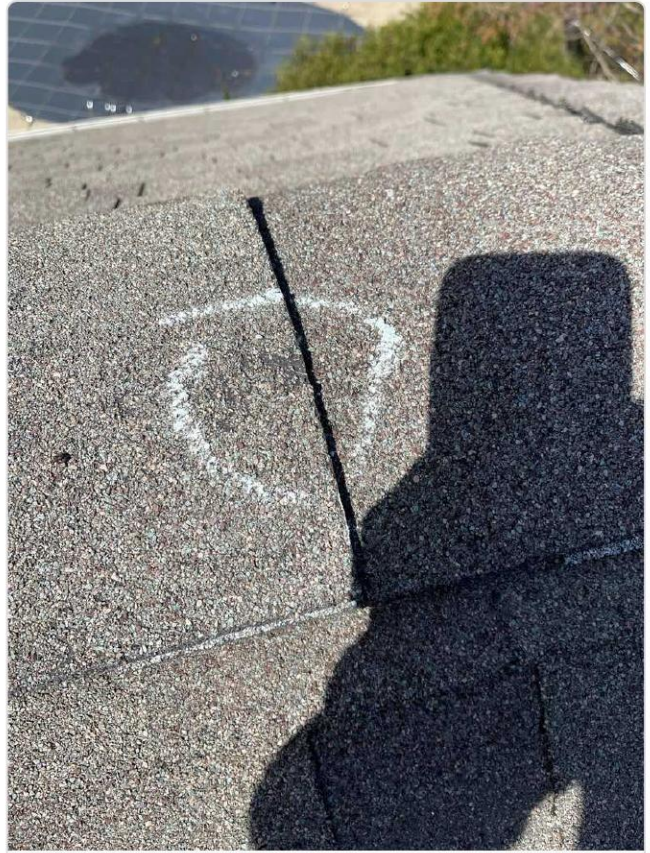
Close-up chalk-circled hail strike on shingle shows granule displacement exposing dark mat — confirmed fracture.

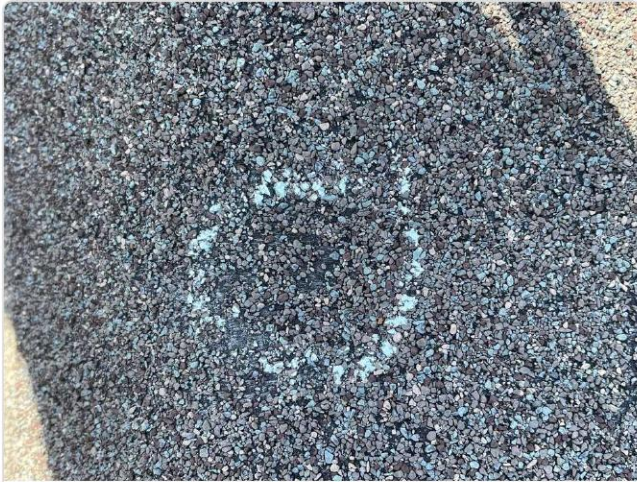
Chalk-circled hail strike on shingle shows granule loss exposing dark mat at impact center.

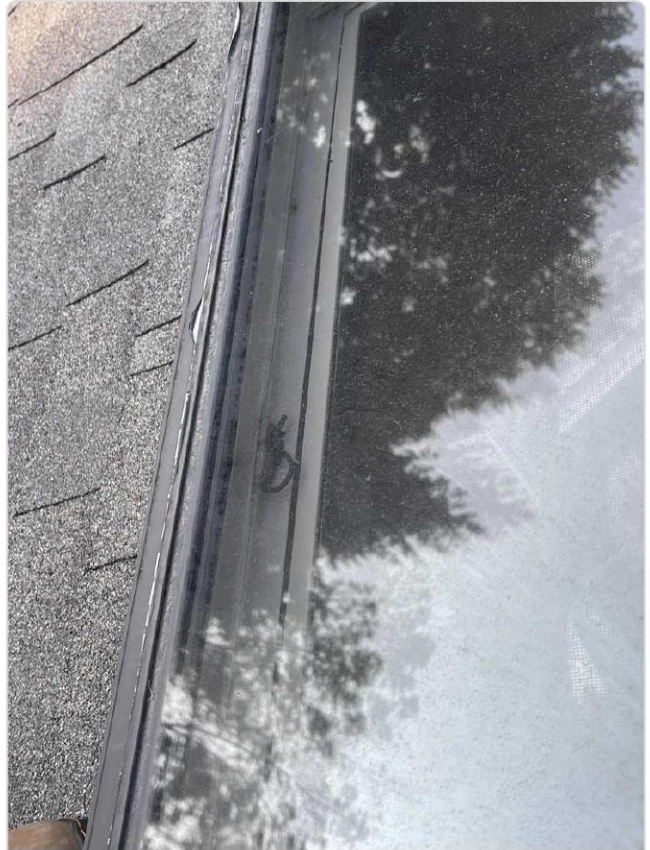
Skylight frame and flashing detail — shingle courses show wind creasing adjacent to skylight edge.

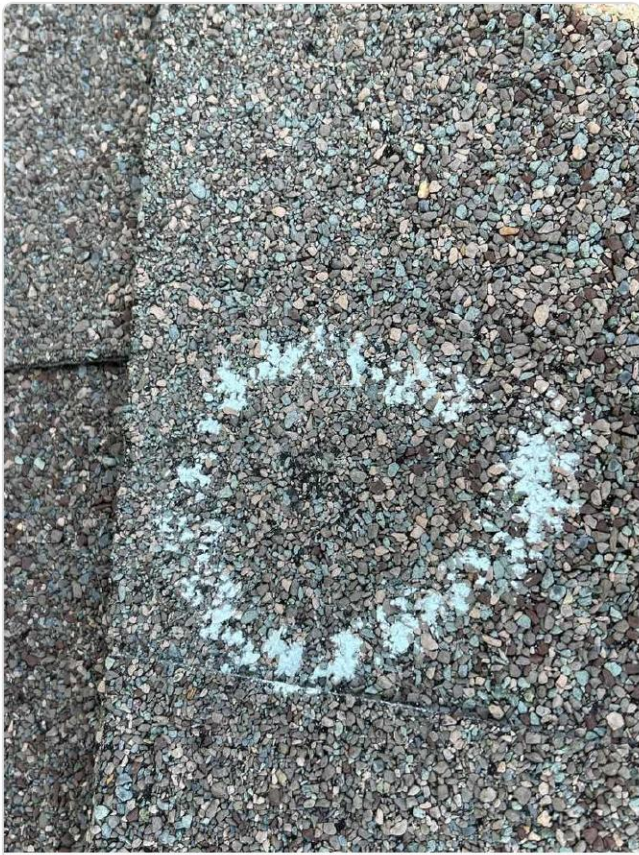
Chalk-circled hail strikes on flat slope near skylight — granule displacement confirms mat fracture.

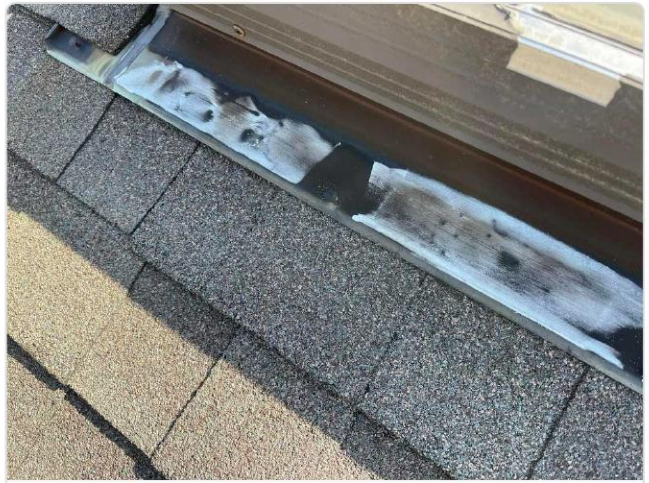
Skylight base flashing shows deteriorated sealant and hail dents on metal apron flashing.

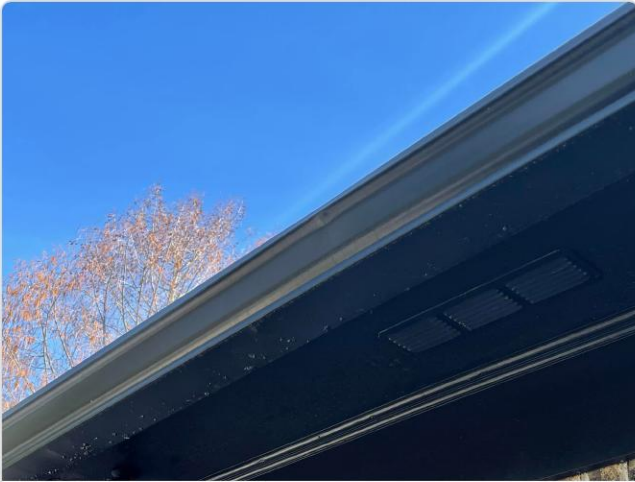
Dark aluminum gutter and soffit vent from below; no chalk test visible but soft metal is candidate for hail dents.

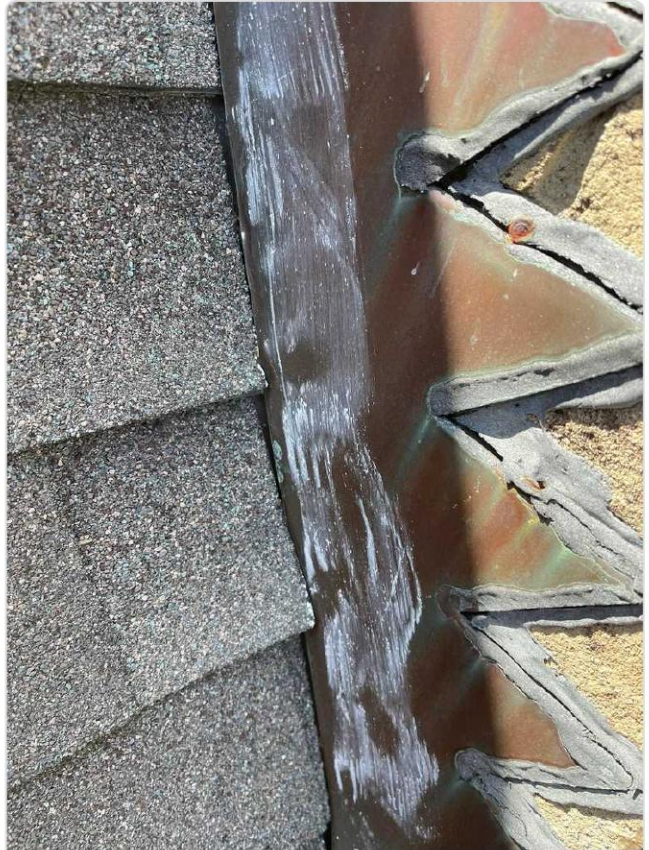
Copper counter flashing at shingle-to-wall transition shows hail dents and splatter — oxidation confirms recent impact.

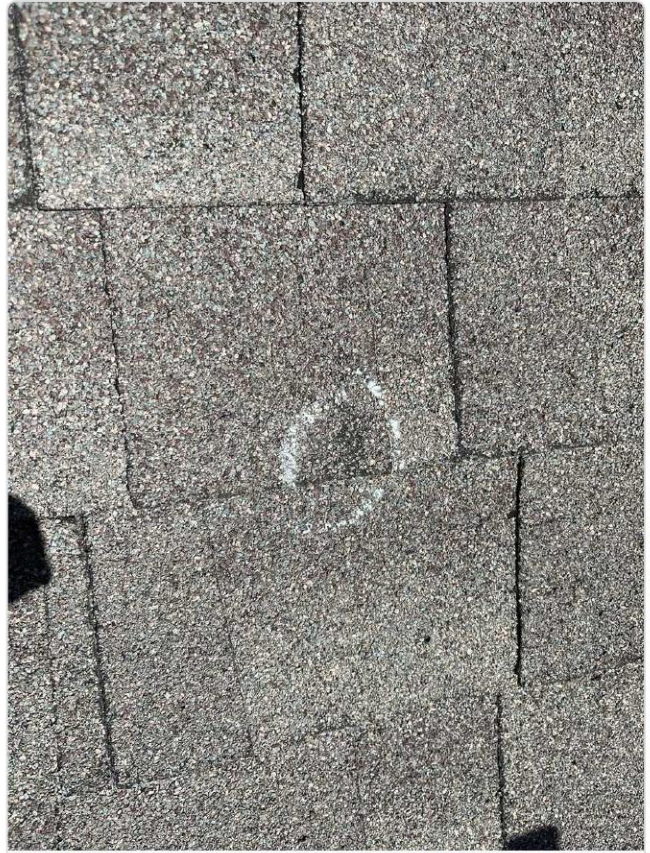
Chalk-circled hail strike on laminated shingle shows granule displacement exposing dark mat — confirmed hail damage.

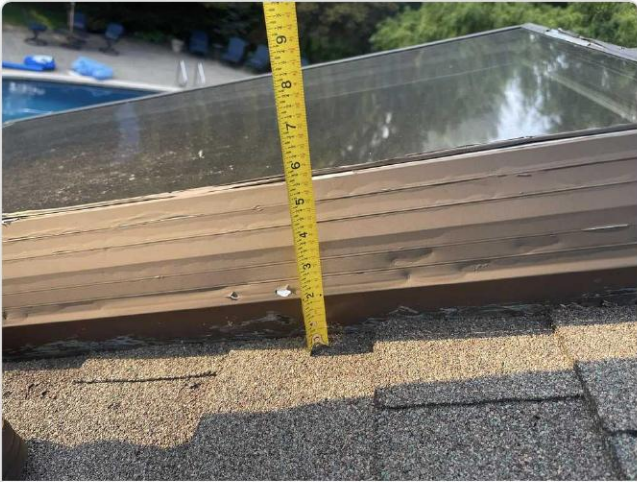
Tape measure shows skylight curb height ~5 inches; hail dents visible on aluminum frame flashing.

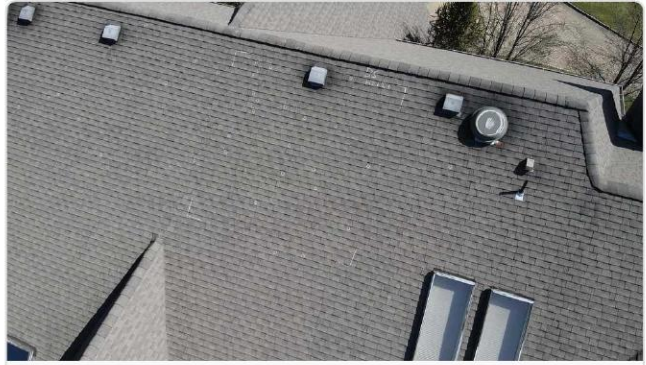
Aerial overview shows chalk-marked test squares with hail hit counts across rear slope and ridge.

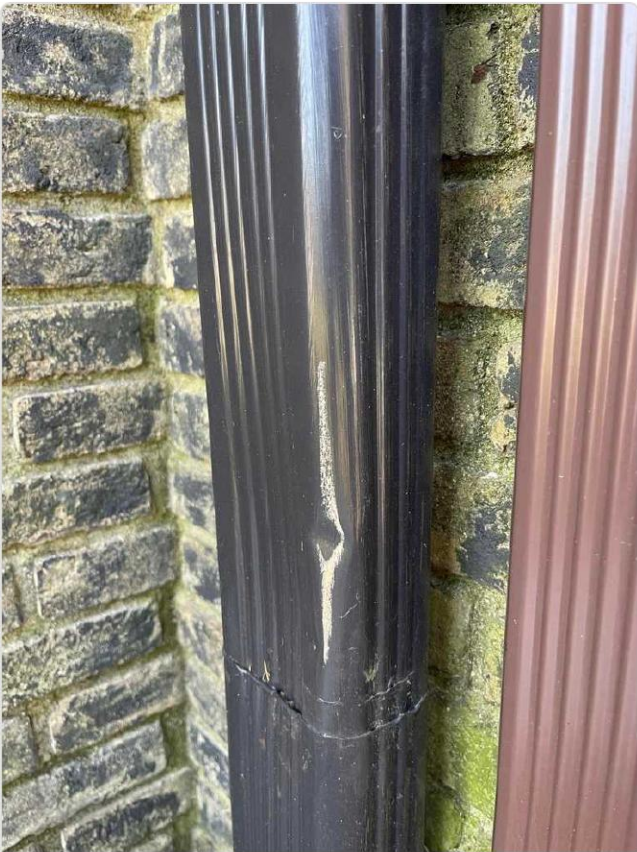
Chalk test on black aluminum downspout reveals circular gap confirming hail dent impact.

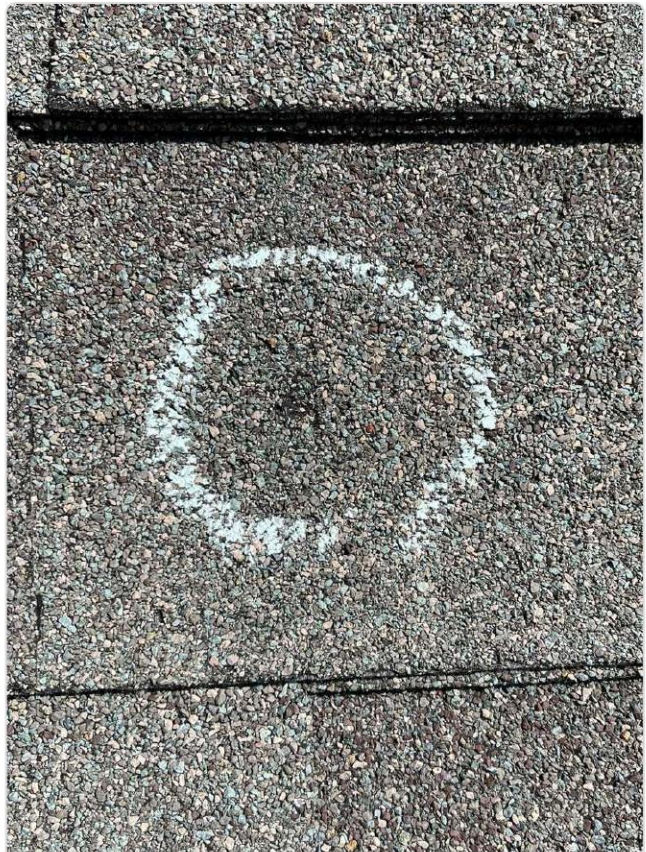
Chalk-circled hail strike on shingle exposes displaced granules and dark asphalt mat.

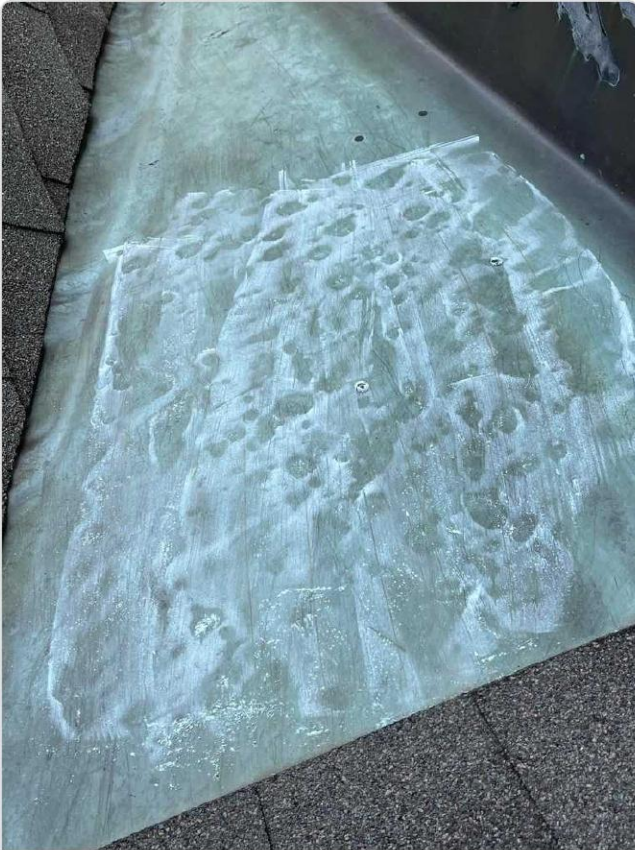
Skylight glazing shows dozens of hail impact pits across acrylic dome surface.

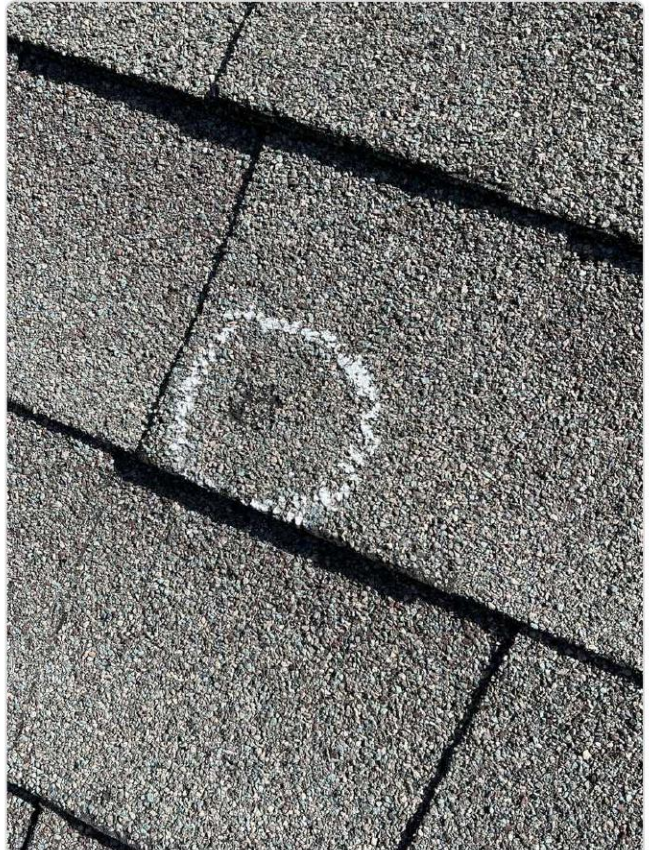
Chalk-circled hail strike on shingle shows granule displacement exposing dark mat — confirmed hail impact.

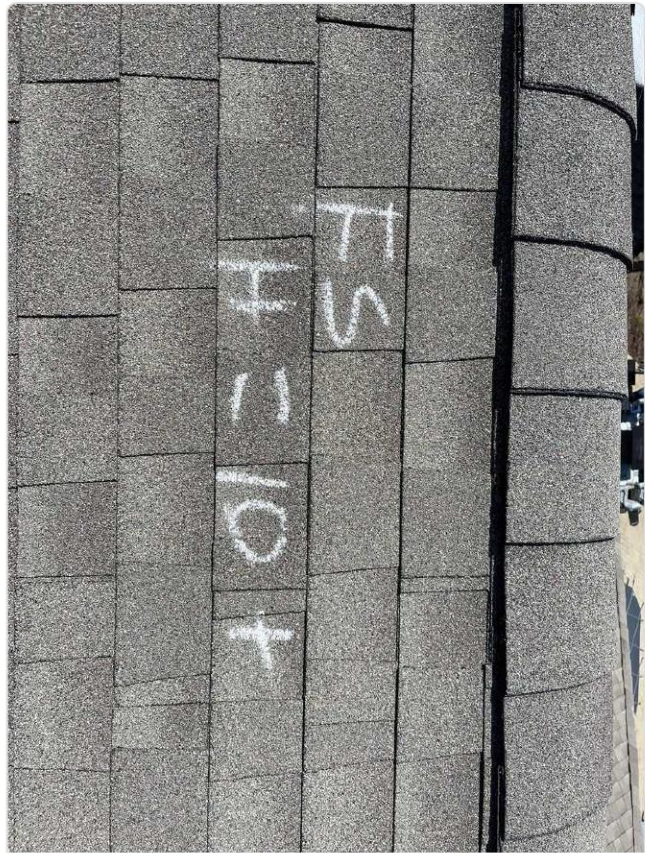
Test square marked 'TS 10+' on front slope — 10+ hail hits confirms density exceeding replacement threshold.
